Oconee Joint Regional Sewer Authority

Report of Findings

Summary of Deficiencies and Work Plan

August 24, 2022

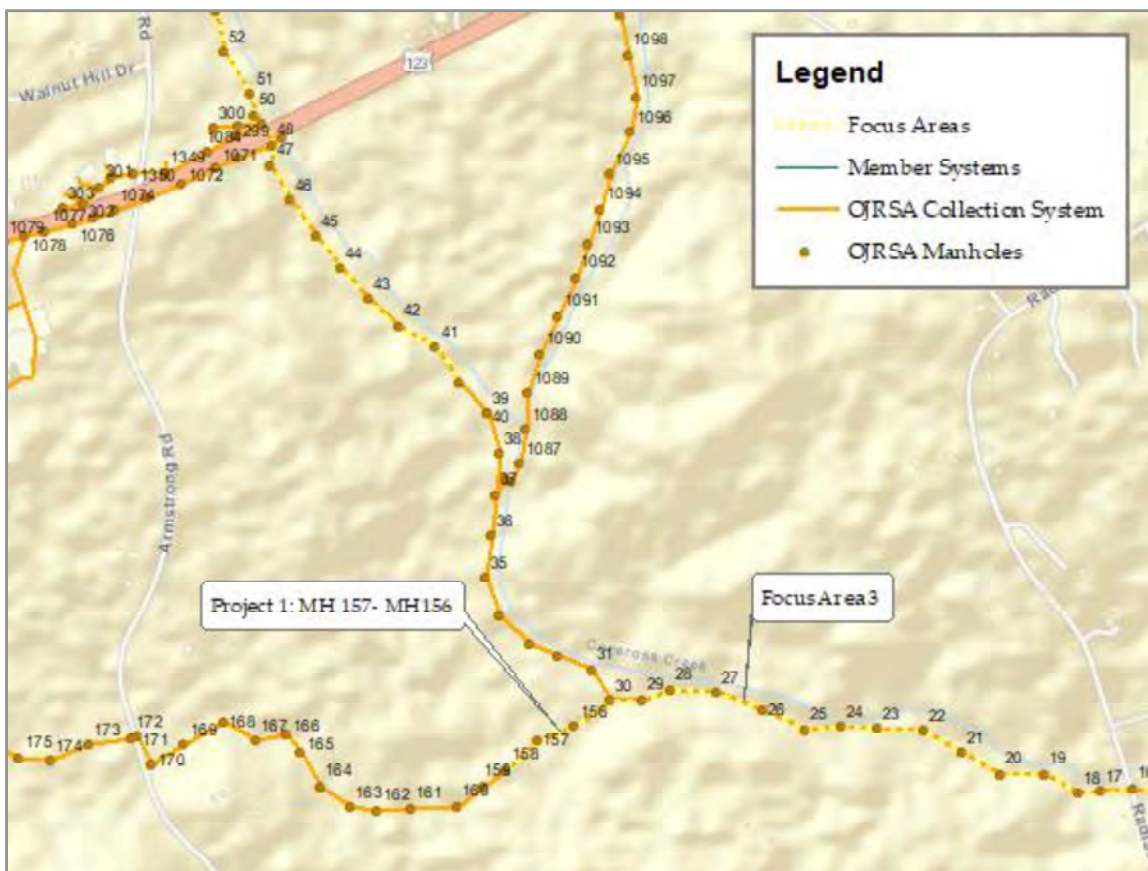
Figure 2. Project 1

This 15" VCP gravity sewer is in poor condition with visible cracks, root intrusions at the joints, section of missing pipe, and signs of groundwater infiltration. A portion of the pipe segment could not be CCTV inspected due to the camera being submerged in wastewater. This is an indication of a sag in the pipe segment.

It is recommended that the pipe be completely replaced from manhole 157 to manhole 156. By replacing the entire segment and not just the portions of the pipe that have defects it ensure a more complete and thorough repair. During the replacement, it should be ensured that the area with the sag is properly backfilled with stabilized soil to eliminate the current sag and prevent future sagging.

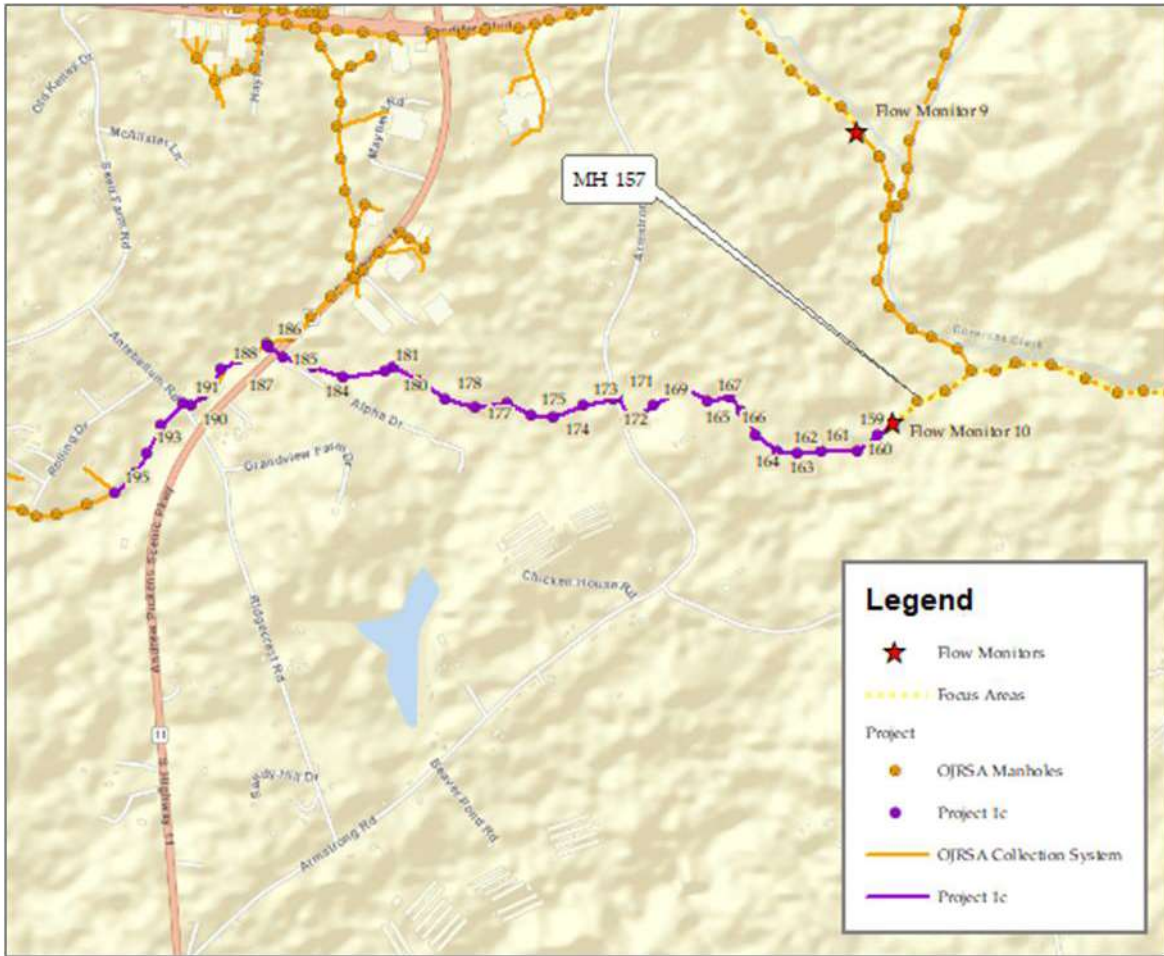
Figure 3. Project 1.c

In response to the CCTV results of MH157-MH156, it is recommended that all upstream segments of VCP between MH 157 and Choestoea Creek Pump Station, not including service connections or tributary sewers be CCTV inspected to determine if similar defects are present. These defects could be sources of I/I and should be addressed in future projects.

Based on evaluation, appropriate repairs and replacement of this section will be determined. If full replacement of this section is needed, the 11,000 LF of gravity sewer may cost approximately \$4,500,000 to replace.

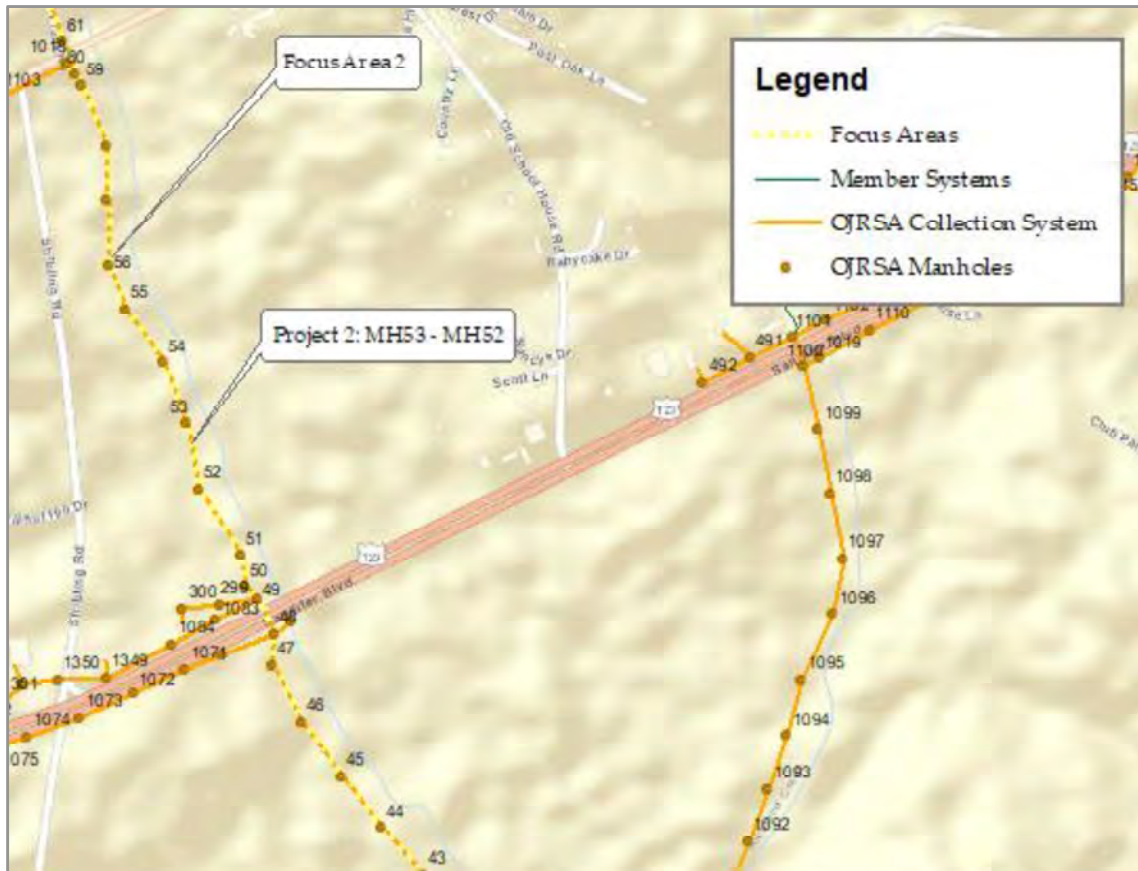
Figure 4. Project 2

This 30" VCP segment includes minor liner defects throughout. An obstruction at the bottom of a sag was found during CCTV. The obstruction has since been cleared, but the sag is still in need of repair. The pipe at the joints on either end of the sag are broken and cracked and have infiltration staining.

It is recommended that a point repair of the sagging segment to restore a uniform slope be completed. During replacement of the existing pipe, soil should be stabilized to prevent future sags.

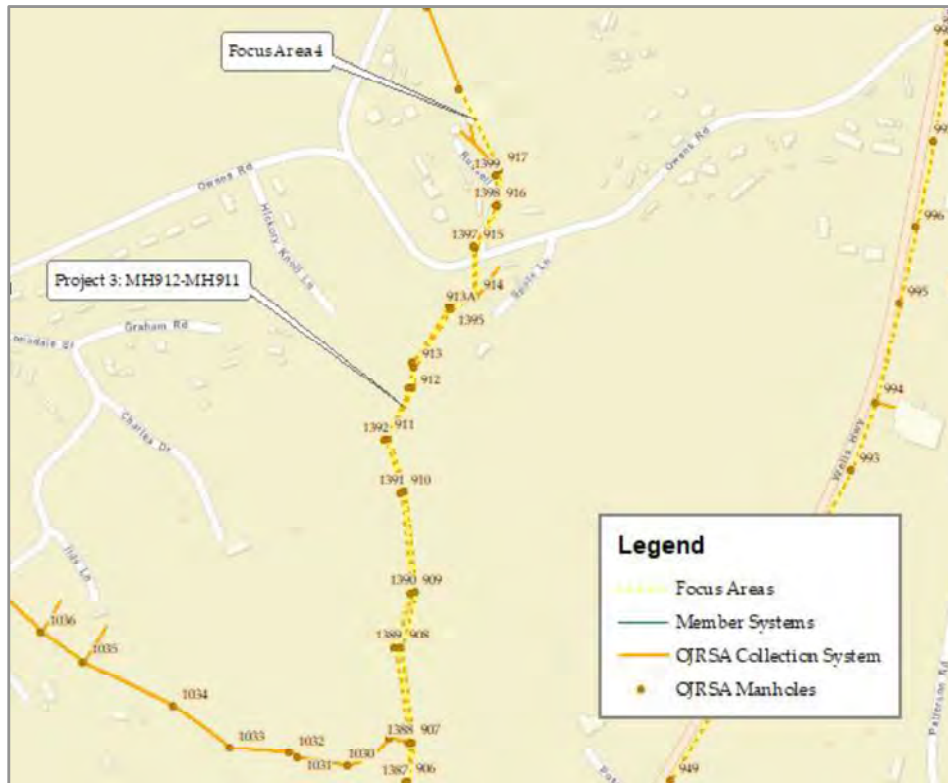
Figure 5. Project 3

This 10" PVC line appears to be severely coated in grease and sludge build up, there are defects that are consistent with a pipe sag. At the connection to the downstream manhole, water is dripping from the top of the pipe and there is also one instance of an infiltration gusher.

It is recommended that this line be cleaned, plugged, and CCTV inspected to confirm sags within the segment. If sags exist, rehabilitative action should be conducted to address the sag. The downstream manhole, MH911, shall be inspected further to determine sources of I/I.

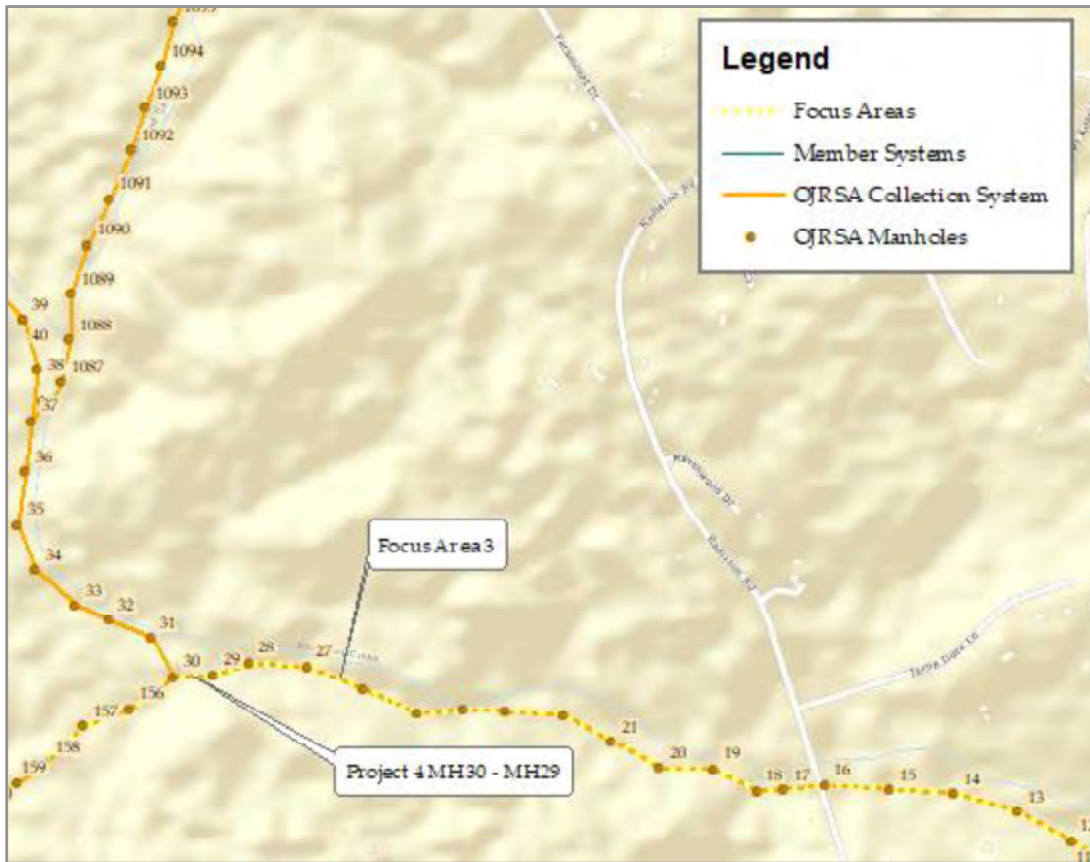
Figure 6. Project 4

This 30" RCP gravity line has some minor linear defects throughout this segment, typical grease buildup, and a handful of joints with minor root intrusion. There is one instance of an infiltration runner and one instance of an unknown obstacle.

It is recommended that this line be cleaned to clear existing grease buildup and remove potential obstructions and eliminate potential sources of I/I with a point repair.

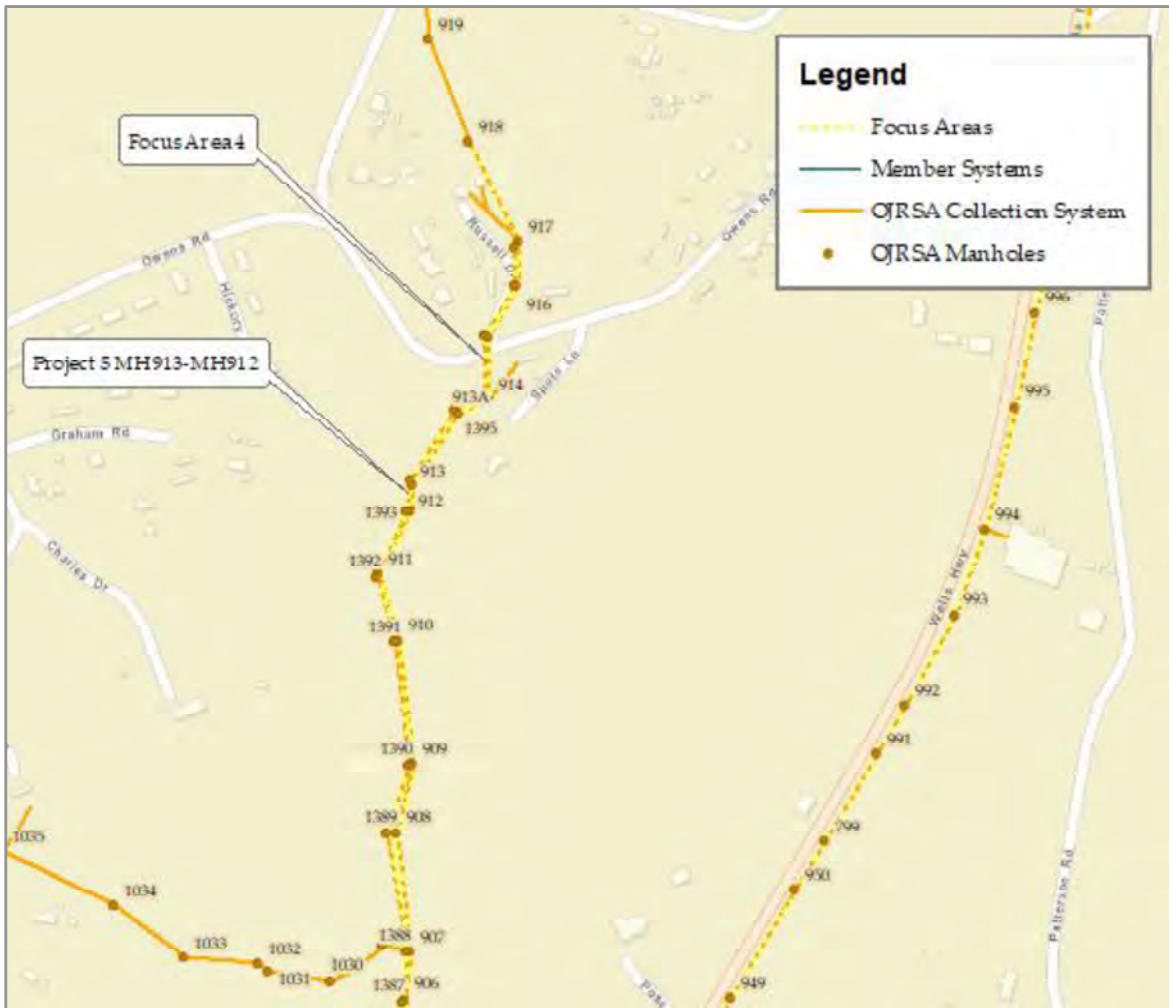
Figure 7. Project 5

This 10" PVC line appears to be severely coated in grease and sludge build up. There is also ragging of grease and debris from the top of the pipe that suggests full stagnant flow at some instances indicating a potential pipe sag.

It is recommended that this line be cleaned, plugged, and inspected with CCTV to confirm sags in the pipe. If sags are confirmed, rehabilitative action should be taken to address the sags.

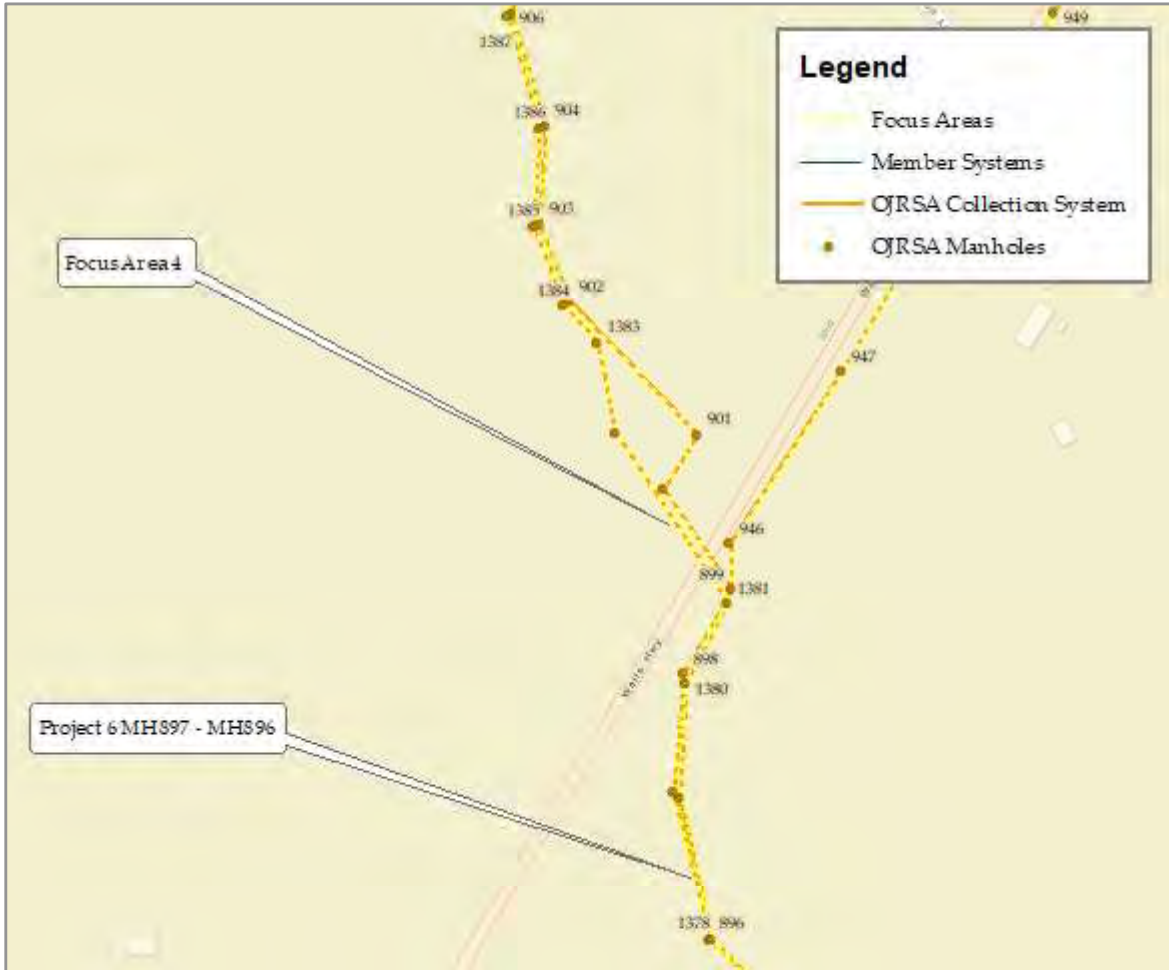
Figure 8. Project 6

During inspection of the 10" PVC line the CCTV camera was submerged indicating two potential pipe sags. There is substantial grease and sludge build up and after instances of sag there is ragging from the top of the pipe.

It is recommended that this line be cleaned, plugged, and re-evaluated to confirm sags in the pipe. If sags are confirmed, rehabilitative action should be taken to address the sags.

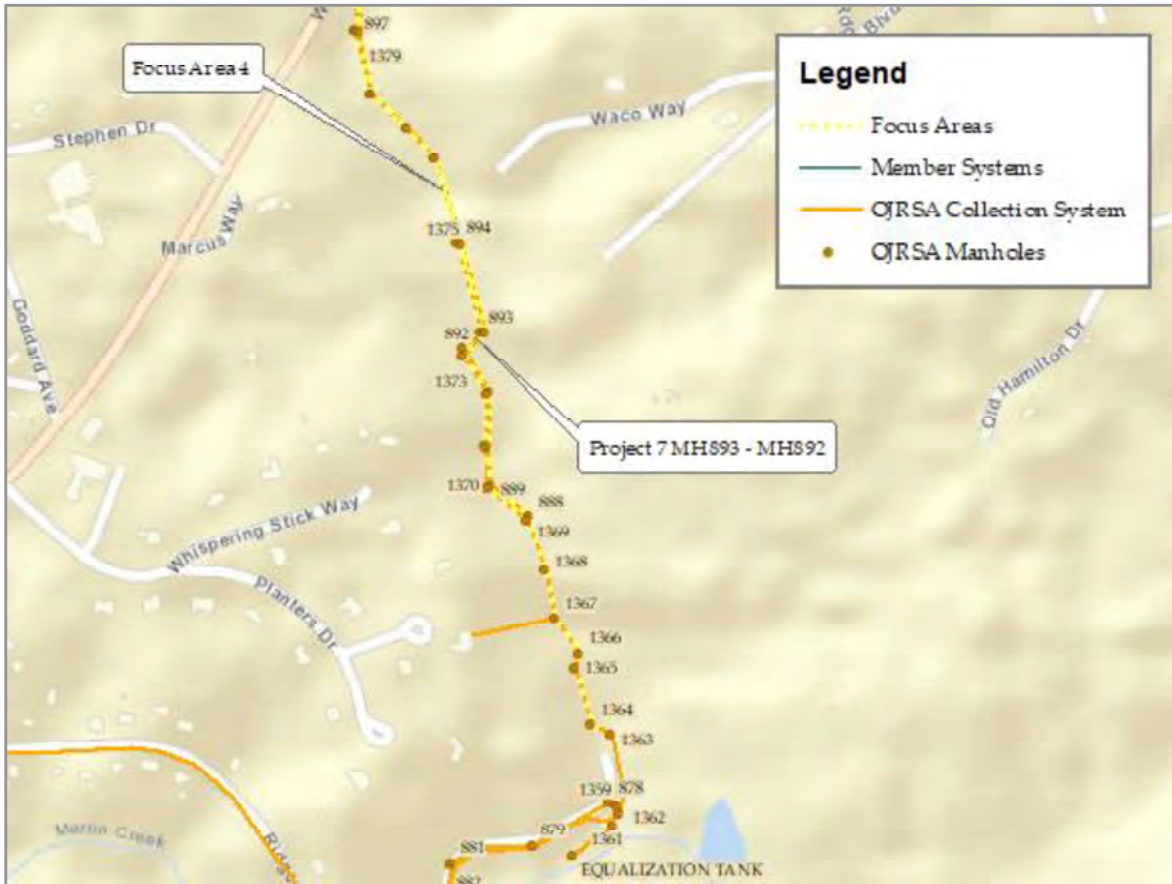
Figure 9. Project 7

During the inspection of this 10" PVC and DIP line, several unknown obstacles were found in the flow path, additionally substantial grease and sludge build up. There was also an instance where the pipe appears to drop significantly, but there was no noticeable joint offset. Further investigation could confirm the presence and extent of any defects.

It is recommended that this line be cleaned, plugged, and re-evaluated to confirm presence of defects. After confirmation of defects is made a corrective action work plan can be developed to address them.

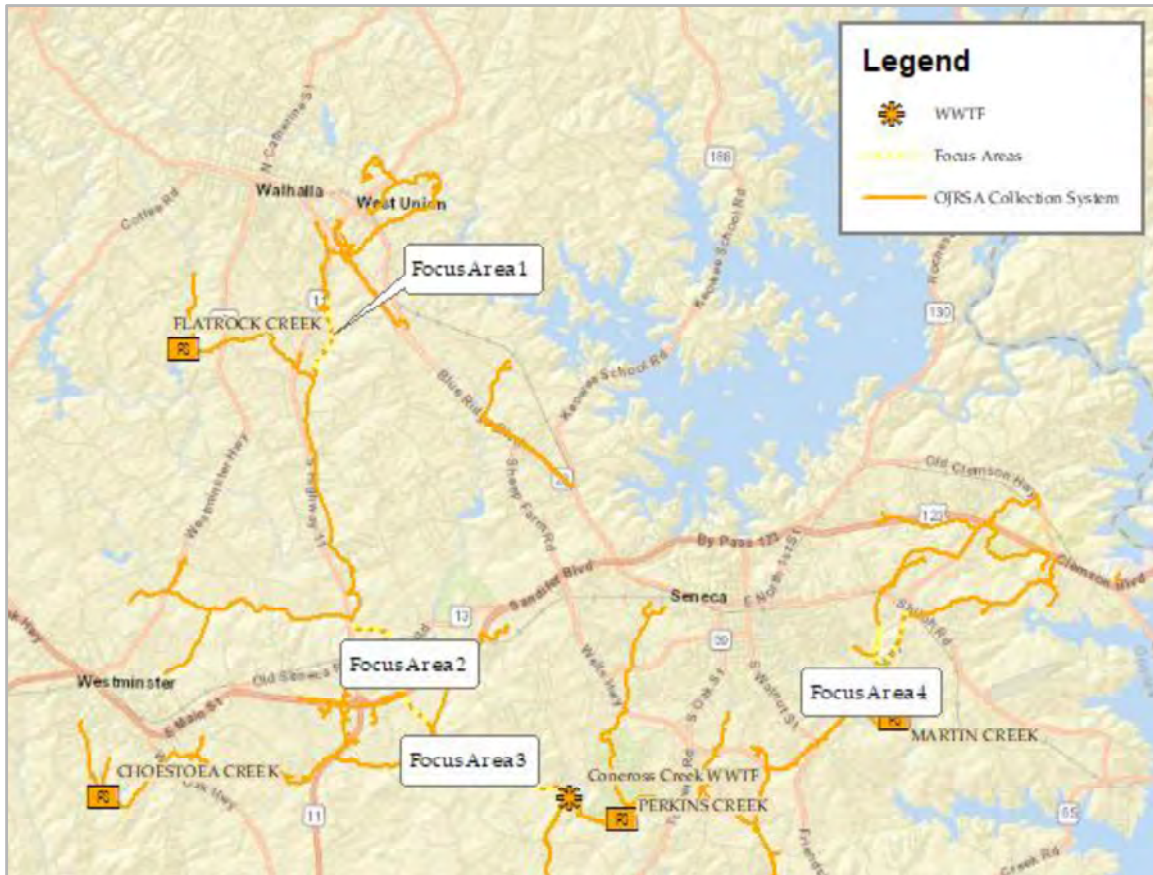
Figure 12. Project 11 Pump Station Evaluation

Table 2 Review of Pump Station Findings	
Pump Station	Findings
Coneross Creek	High pump runtimes
Perkins Creek	High pump runtimes
Martin Creek	High pump runtimes
Choestoea	High peaking factor
Flat Rock	High peaking factor

These evaluations should seek to determine the causes of the high pump runtimes and high peaking factors. The estimated cost for this evaluation is \$90,000.

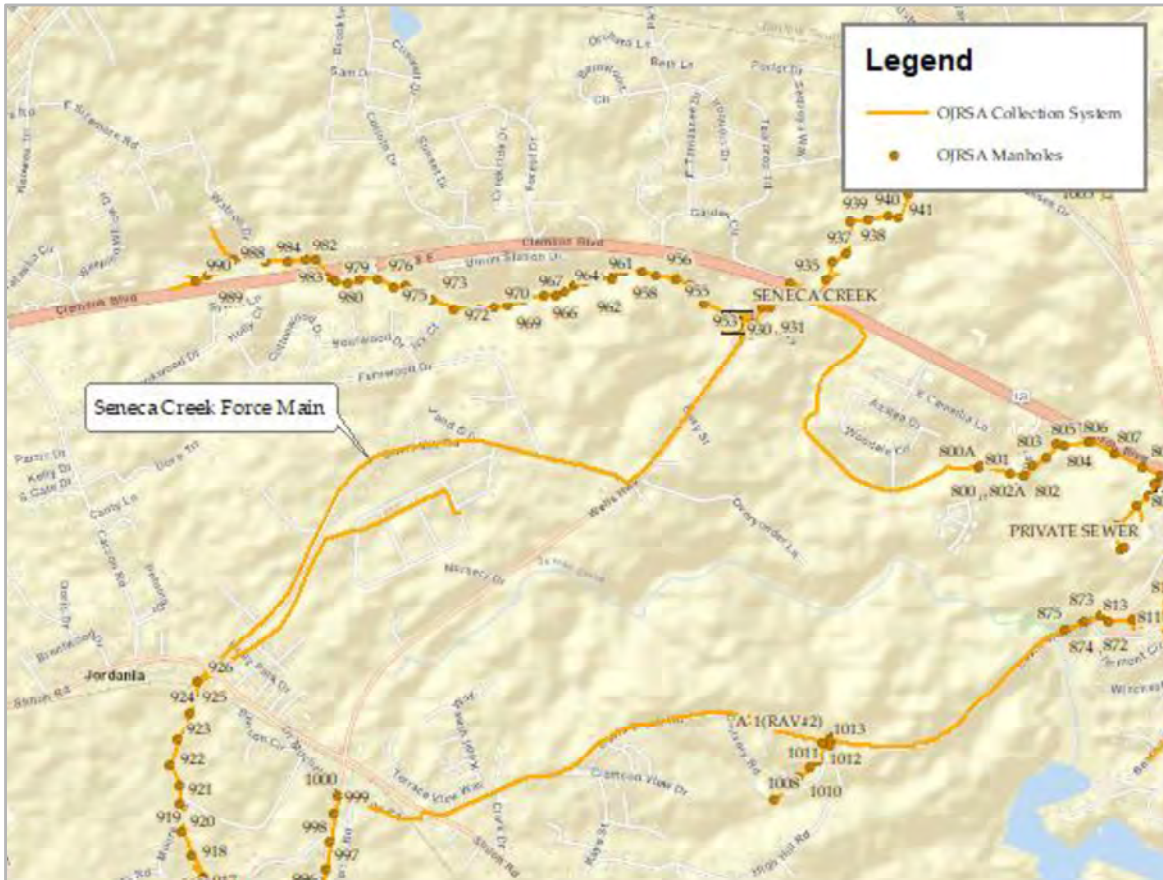
Figure 13. Project 12 Seneca Creek Force Main Evaluations

Due to failures associated with force mains, Seneca Creek and Speeds Creek force mains were identified for further evaluation.

It is recommended that the force mains be inspected for corrosion and the ARVs be assessed for proper function. Additionally, due to historical, repetitive failures within Speeds Creek force main, an investigation to determine the cause of failures should be

made. Upon determination of the cause of these repeated failures, necessary actions to prevent future failures should be taken as part of the future projects.

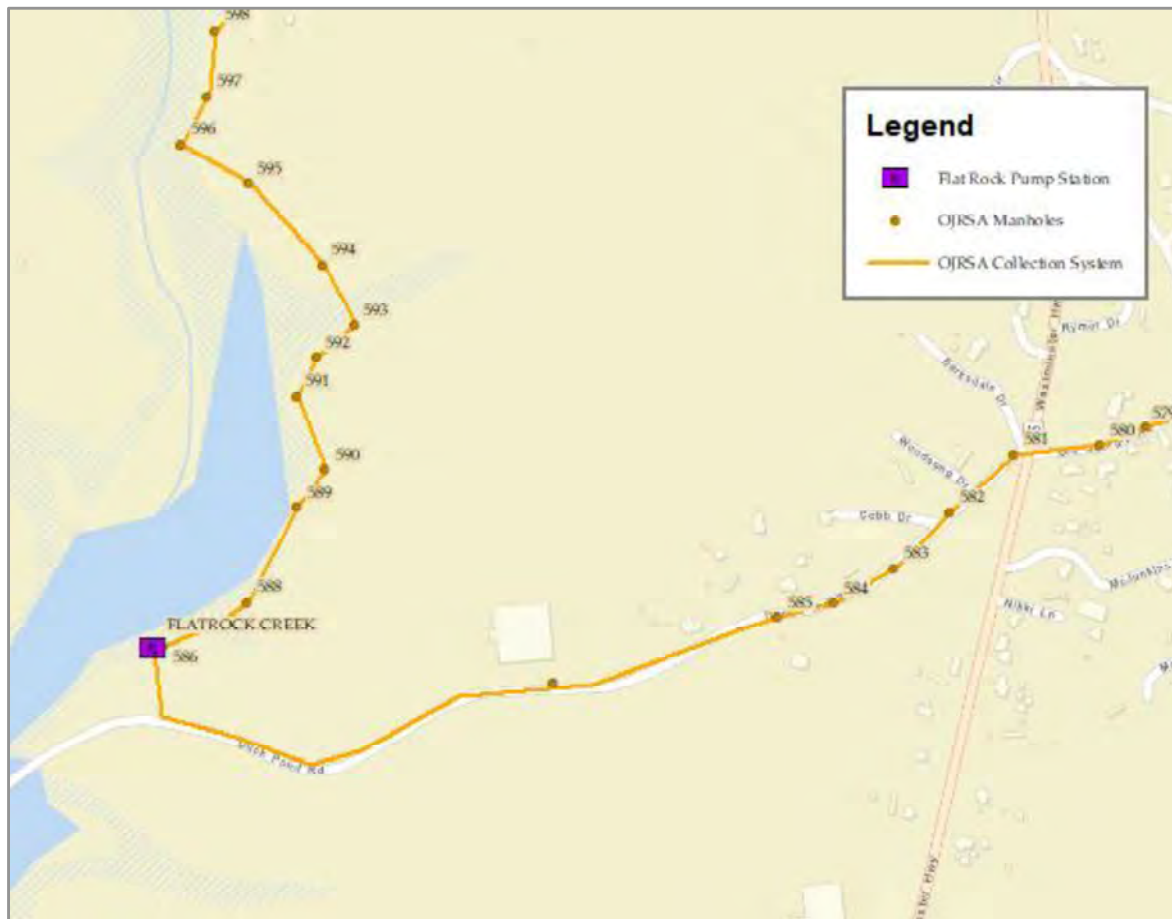
Figure 15. Project 13 Flat Rock Creek Pump Station

The Flat Rock Pump Station serves an area southwest of Walhalla and the Oconee County Detention Center. Recent drawdown tests indicate that the existing pumps are performing below the original design flow rate of 250 gpm. OJRSA plans to increase the capacity of this pump station to 300 gpm to relieve the stress on the sewer system in the area. Additionally, a large amount of debris enters the waste stream interfering with downstream wastewater operations including ragging and blockages at the pump station. By upgrading the pump station, the debris can be removed at the pump station prior to causing blockages in the waste stream.

- ◆ Installation of a new wetwell
- ◆ Vertical Barscreen, compactor, and dumpster
- ◆ Duplex submersible pumps
- ◆ Permanent standby generator
- ◆ Demolition of existing wetwell, pump station structure, and radio communications towers
- ◆ Site work; including fencing, improved vehicle access, and water service
