Oconee Joint Regional Sewer Authority

Report of Findings

Summary of Deficiencies and Work Plan

August 24, 2022

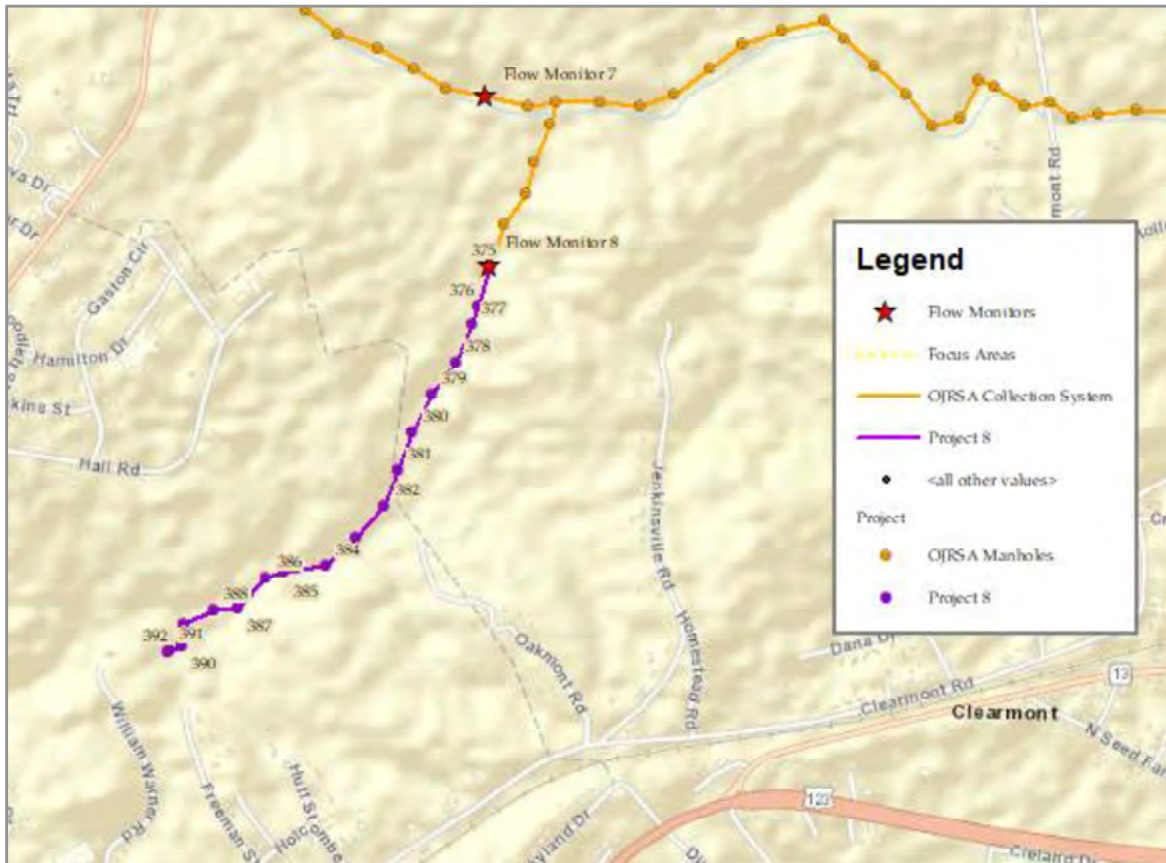
Figure 10. Project 8

This is estimated to be roughly 5,000 LF of gravity sewer and will cost \$30,600 to inspect and \$8,000 to in fees to evaluate.

Based on evaluation, appropriate repairs and replacement of this section will be determined. If full replacement of this section is needed, the 5,000 LF of gravity sewer may cost approximately \$2,250,000 to replace.

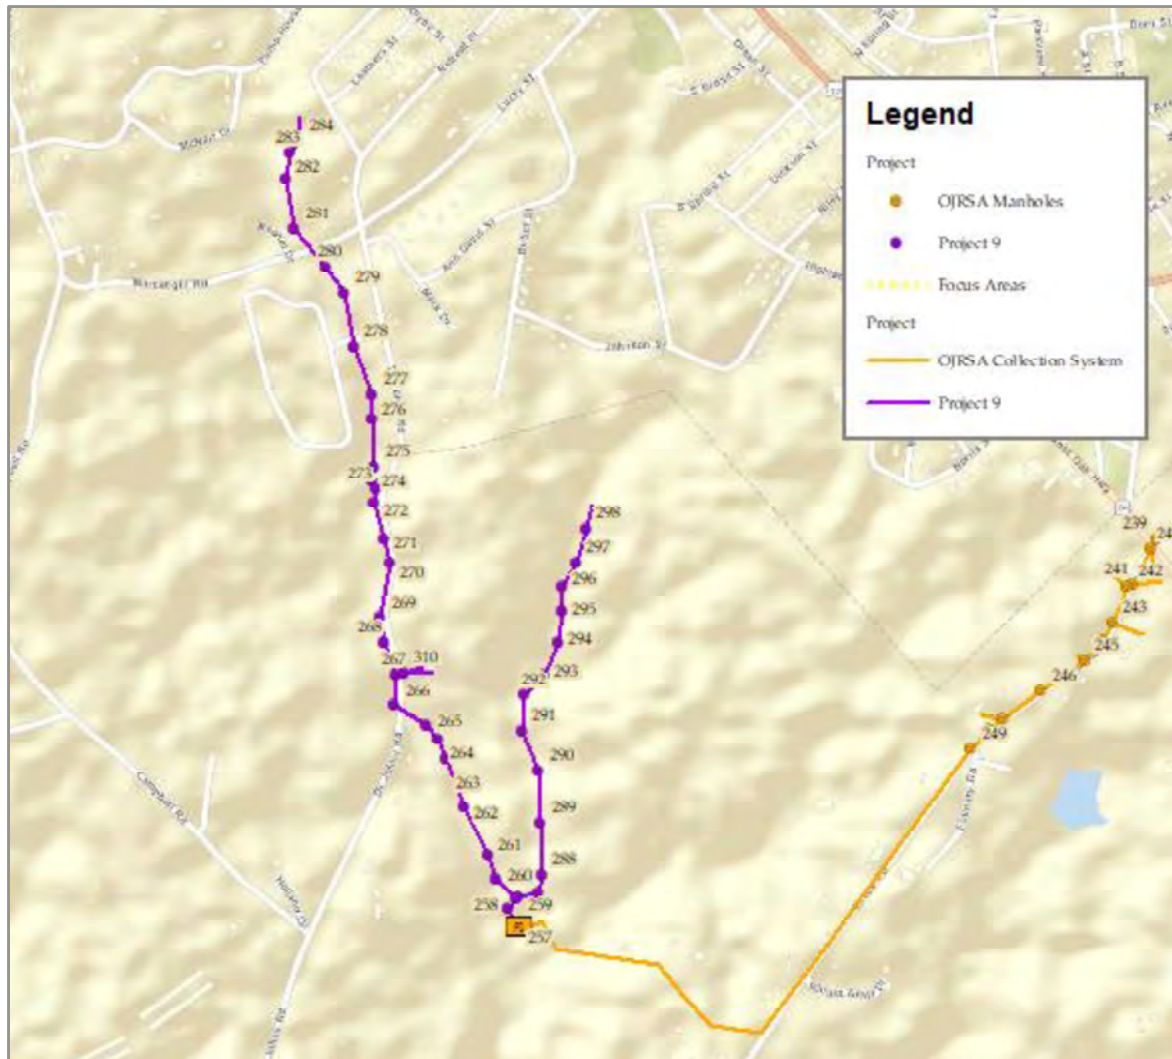
Figure 11. Project 9

CCTV Evaluation from Choestoea Pump Station to the connection with Westminster. This is estimated to be roughly 9,000 LF of gravity sewer and will cost \$43,500 to inspect and \$13,000 to in fees to evaluate.

Based on evaluation, appropriate repairs and replacement of this section will be determined. If full replacement of this section is needed, the 9,000 LF of gravity sewer may cost approximately \$4,000,000 to replace.
